Addressing Panel Sink in Plastic Bottles

Joseph Haun, Quality Engineer
TricorBraun Design and Engineering

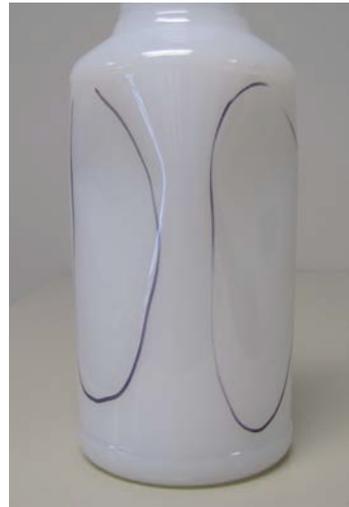
Panel Sink 1: Black marks indicate the extent to which the side panels on this bottle have shrunk.

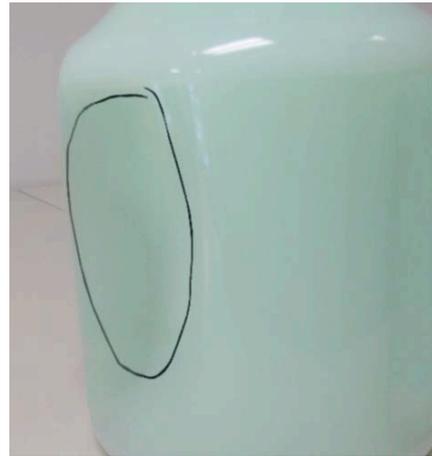
Panel sink 2 The panels on this bottle have begun to sink, but have not yet affected the adhesion of the label.

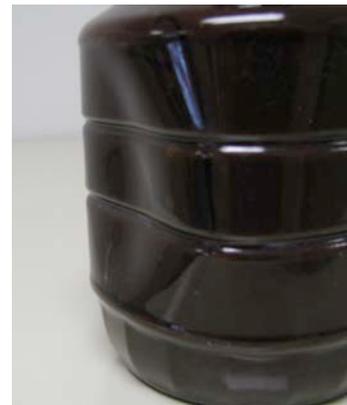
Panel sink 3 The design of this bottle did not provide enough strength to resist panel sink.

The more effective alternative is to improve the structural integrity of the bottle walls. This can be accomplished either by slightly changing the shape of the bottle, from a straight cylinder shape to an hourglass or other shaped structure, or by adding ribs to the panel area. These can be either plain longitudinal ribs or annular ribs around the bottle perimeter or ribs incorporated into a design so they do not detract from the visual appeal of the bottle.

These design changes add structural strength by replacing flat areas with curved elements that resist the pressure. This solution enables a brand owner to overcome panel sink problems without incurring the cost of adding material to a bottle.
